# Monitoring corrosion in district heating systems

**Project number: 00071**

***Final Report***

**May 2004**

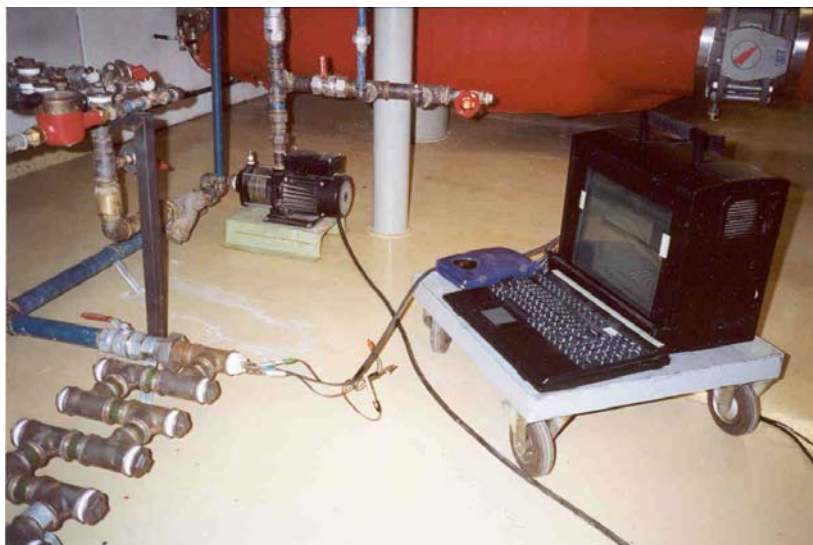
**Fig.. 4.3.43. Corrosion test unit set-up at Oskjuhlid.**

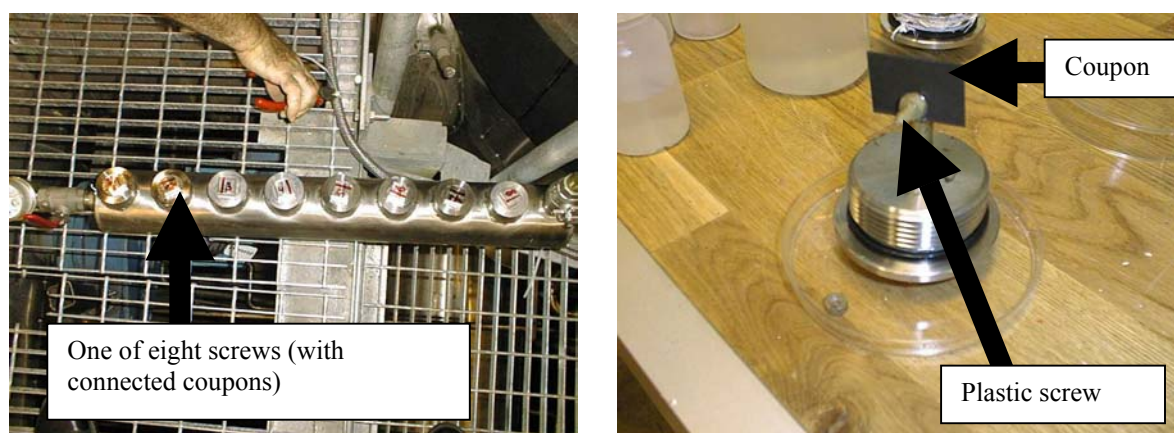
**Fig. 4.5.1. Exposure container used during phase 1.**

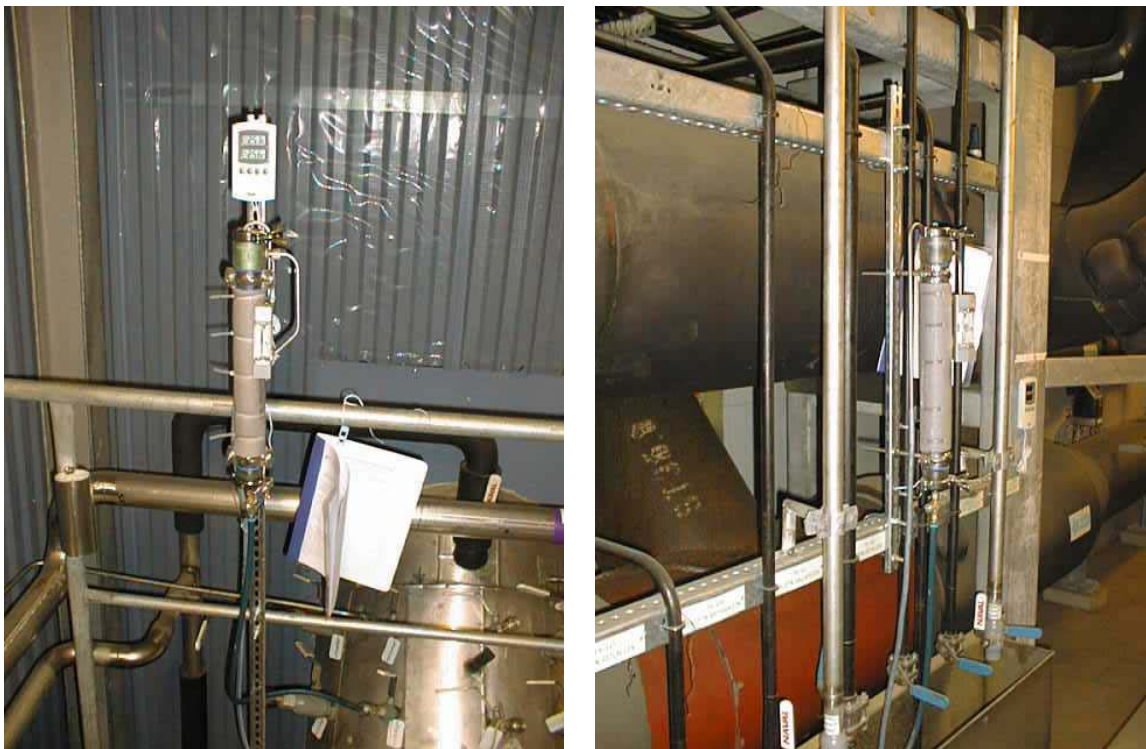
**Fig. 4.5.3. Examples of locations for connection of exposure containers.** The picture to the left is from the net at Värtan and the other picture is from the net at Solna. The exposure containers are covered with a foam plastic case for avoiding possible interference from surrounding light. Beside the exposure containers is a notebook for regularly notifications of the temperature and the flow of the district cooling water.

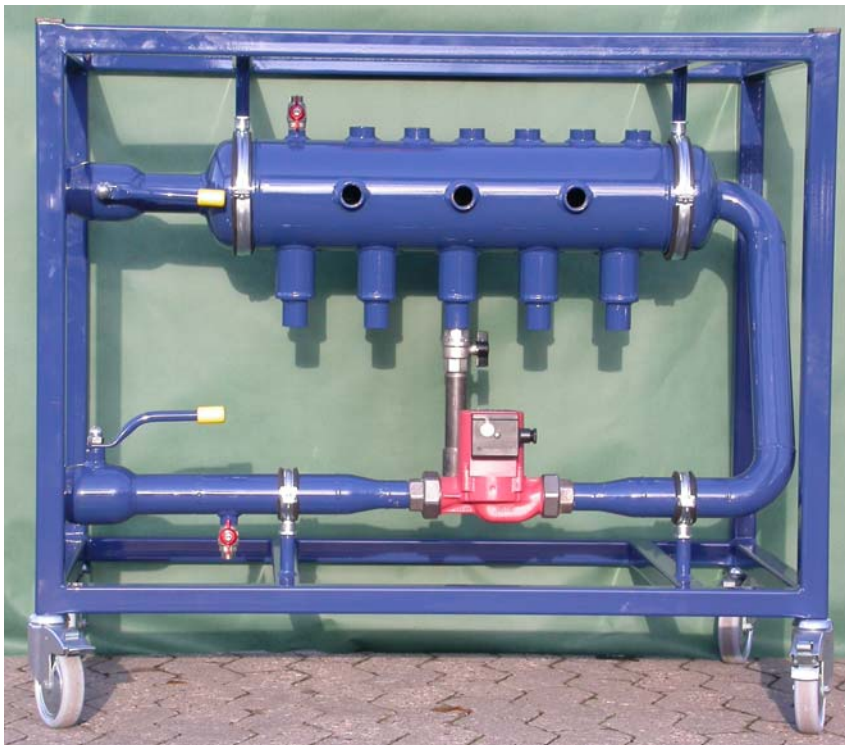
**Fig. 4.6.10. Redesigned bypass unit shown without probes.**

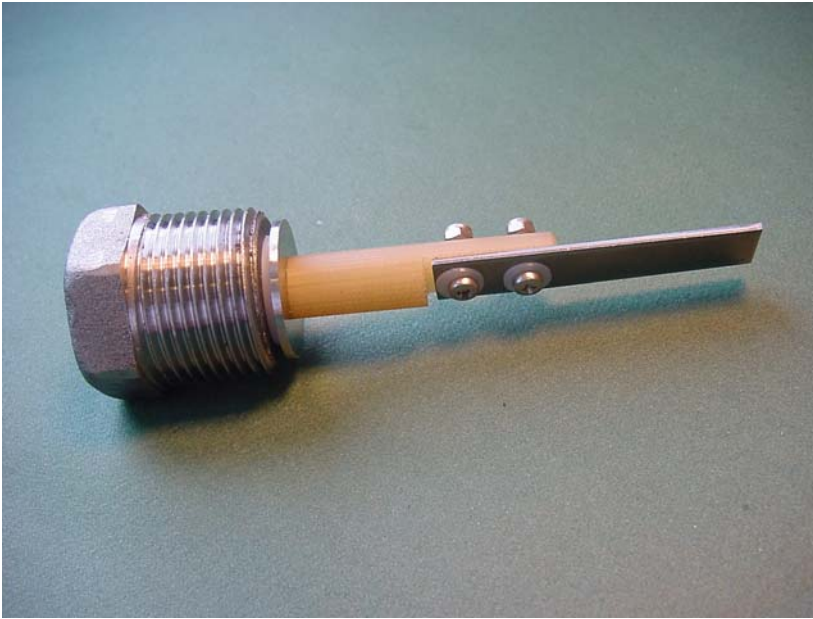
**Fig. 4.6.11. New design of weight loss coupons with carbon steel disc for bio analysis.**
